RE: ScrapCom
Assessment
Correspondence
RCRA C - Hazardous Waste
Cuyahoga County
OHD980681571

Subject: RCRA Corrective Action Remedy Construction Complete (CA550RC) and Corrective Action Performance Standards Attained-Controls Required (CA900CR), ScrapCom, OHD980681571

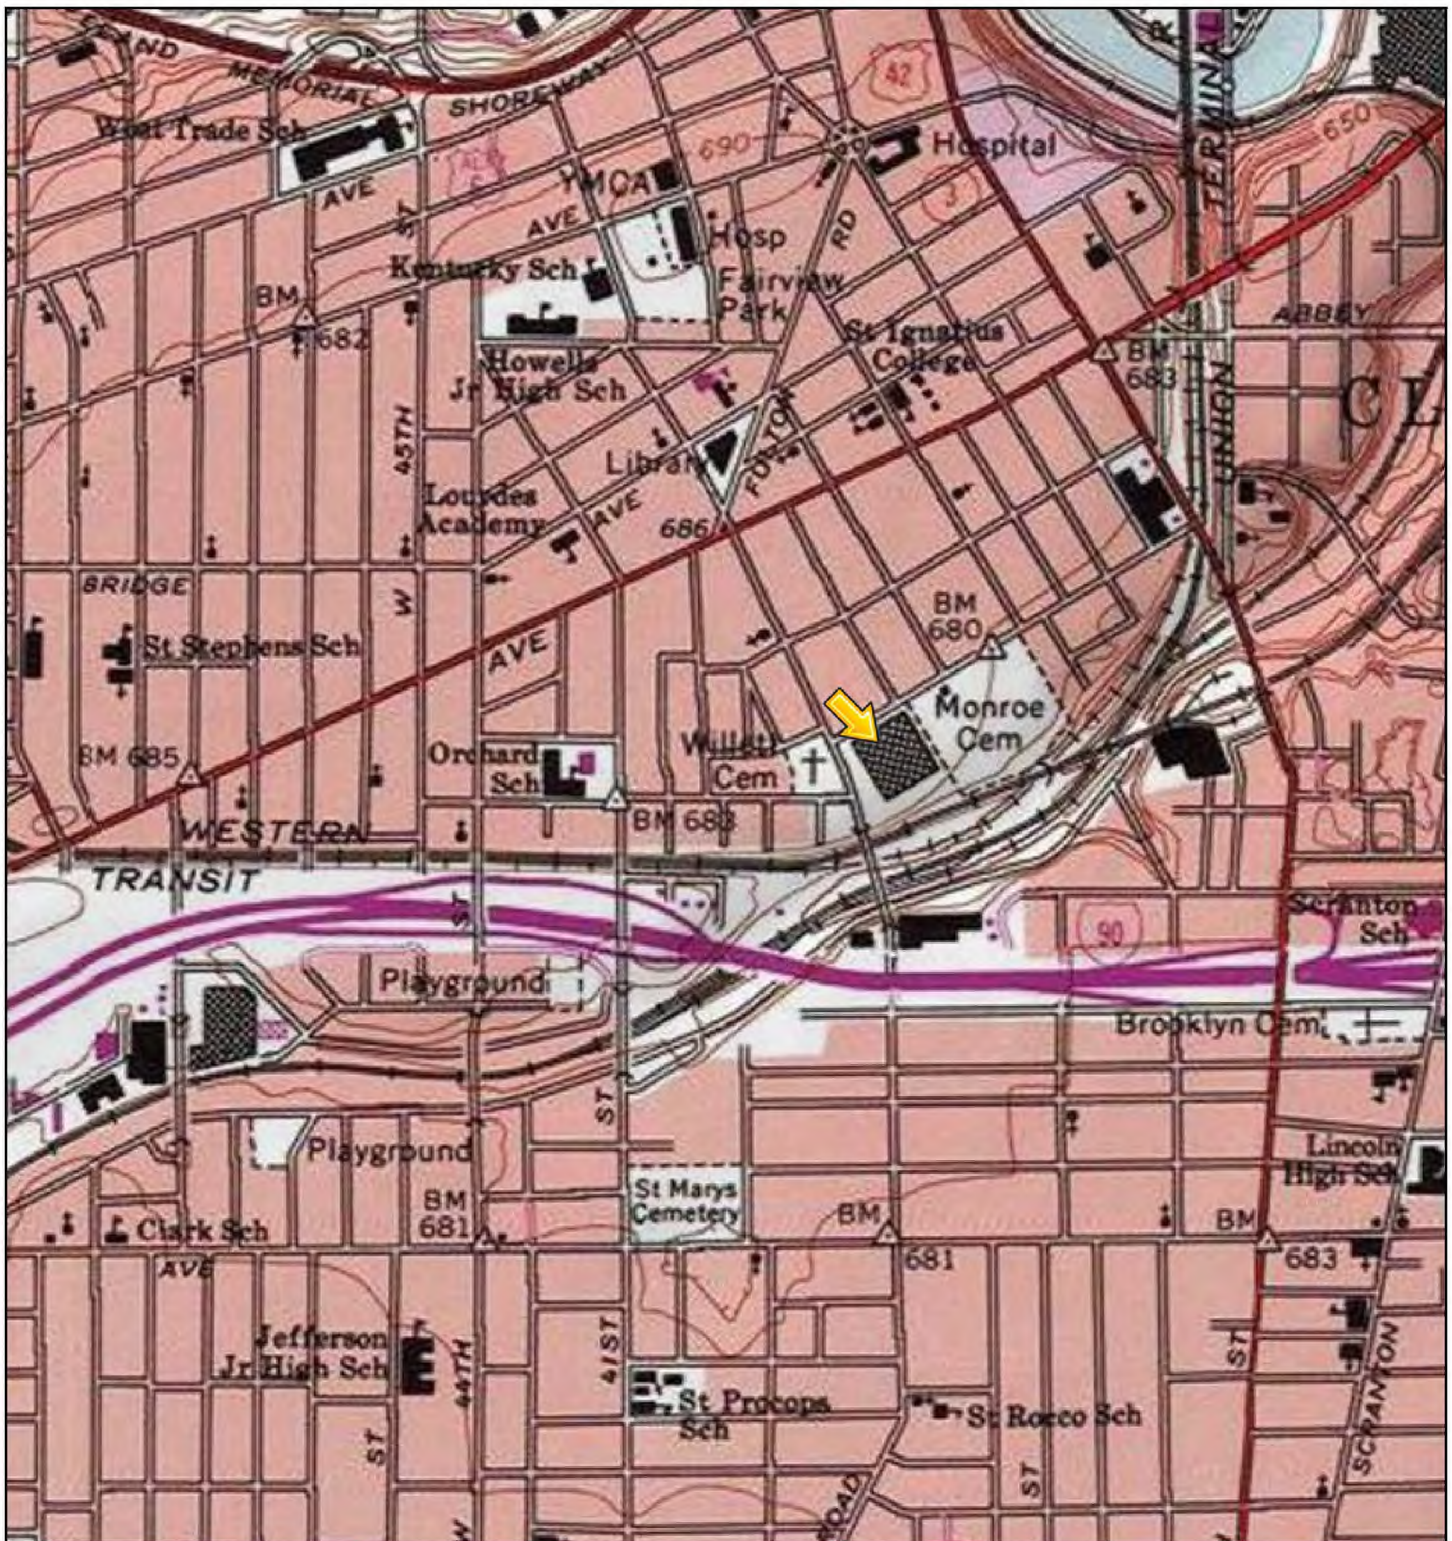
Figure 1: Property Location Map – taken from Post-Closure Plan

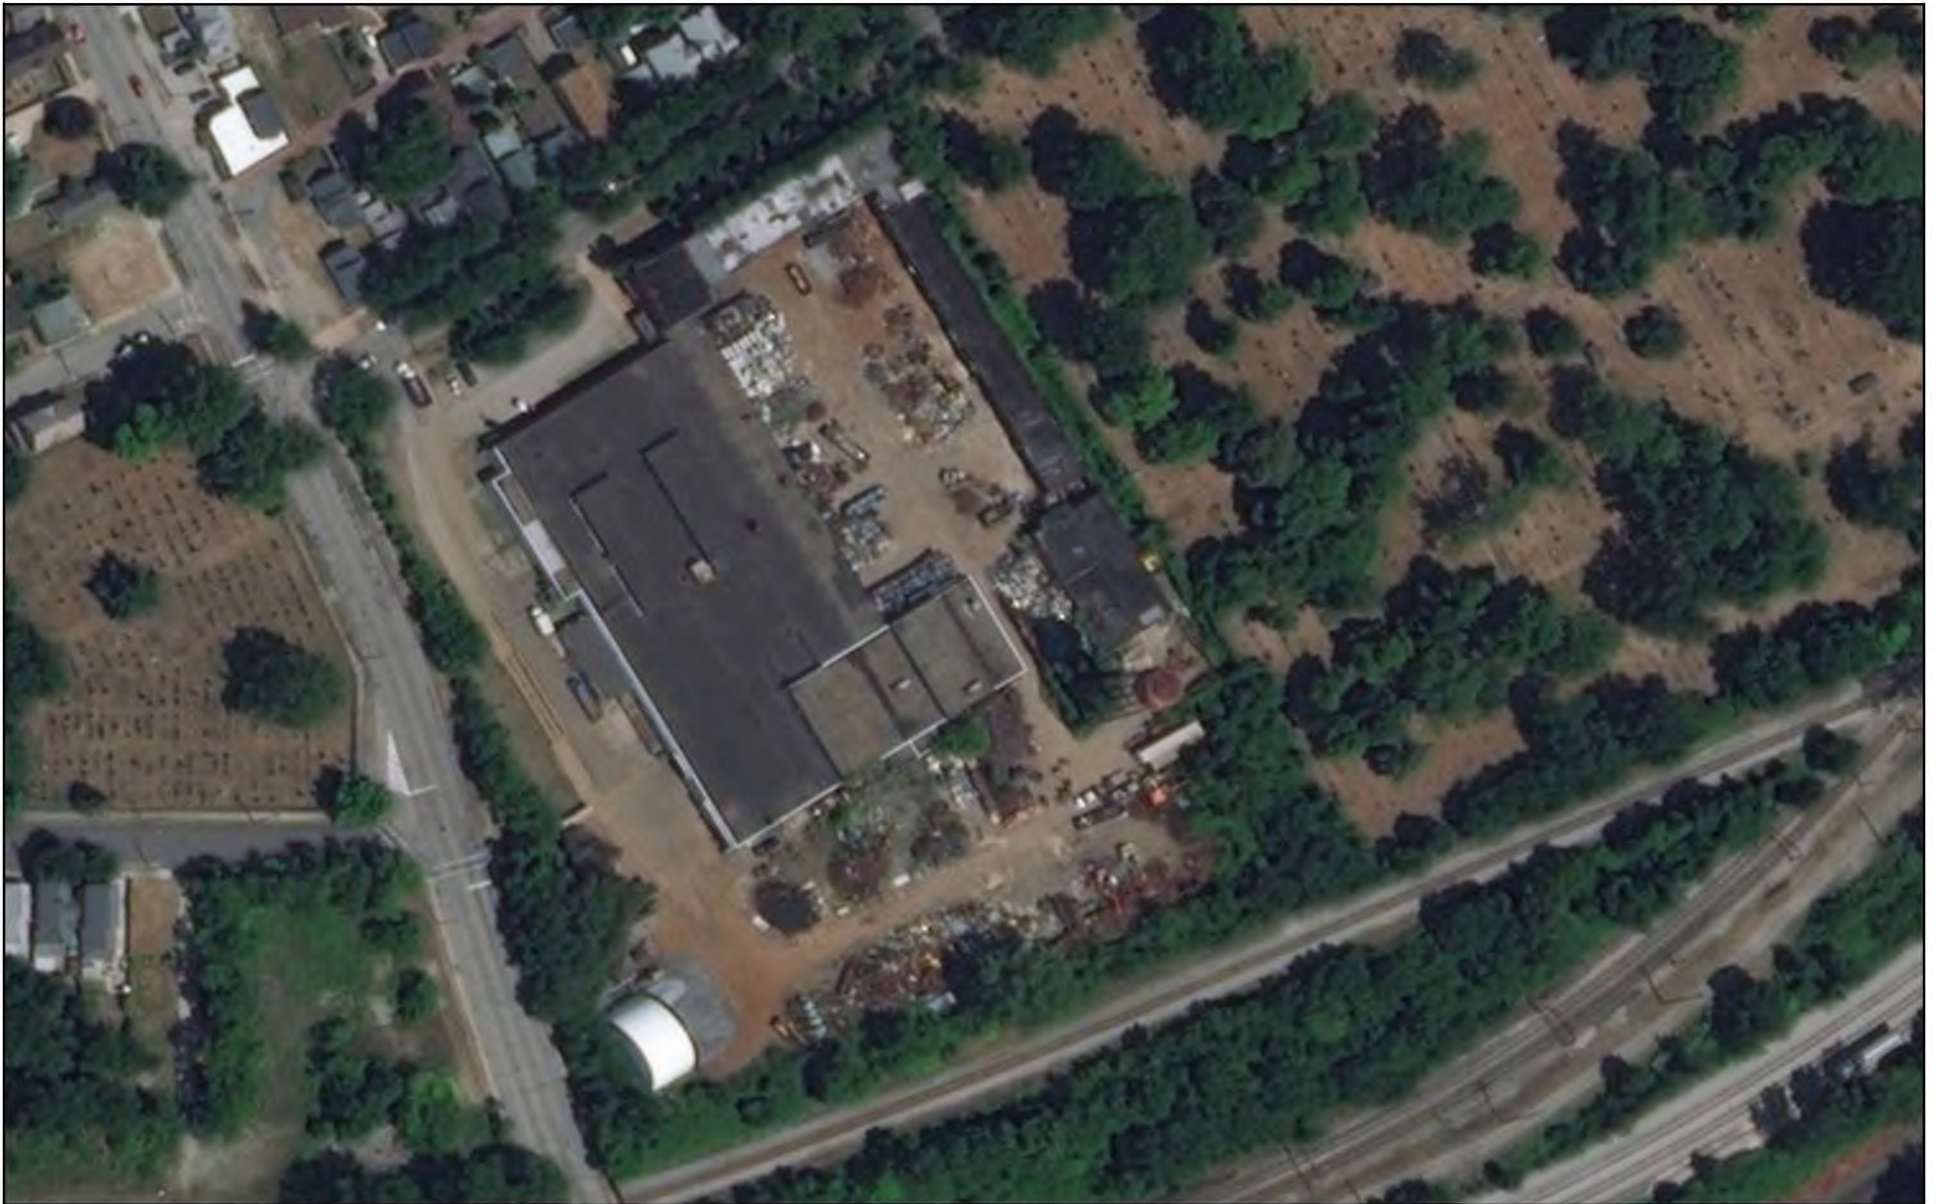
Figure 2 - Property and Surrounding Area

Figure 2: Property and Surrounding Area – taken from Post-Closure Plan

The Facility is located at the southeast corner of the intersection of Monroe Avenue and Fulton Road and encompasses approximately 7.6-acres in a mixed commercial/residential area. The Facility consists of two tax parcels identified as Permanent Parcel Numbers 00714002 and 00714003 in Cuyahoga County records. Buildings on-site occupy a total land area of ~148,946 square feet and include a former laboratory and office complex (vacant), a large warehouse currently used for storage of scrap metal and materials, a loading and unloading dock, maintenance building, and several buildings that have been razed with the foundations remaining. This list is not all inclusive. Lake Erie is approximately one mile to the north and the Cuyahoga River is one mile to the east. There is a cemetery directly east of the Facility and another to the west, across Fulton Road. To the south, is a rail line. Across Monroe Avenue to the north are residential dwellings. See Figures 1 and 2.
